# **Cleveland Heights Partial Consent Decree 2018 Annual Report**

March 18, 2019

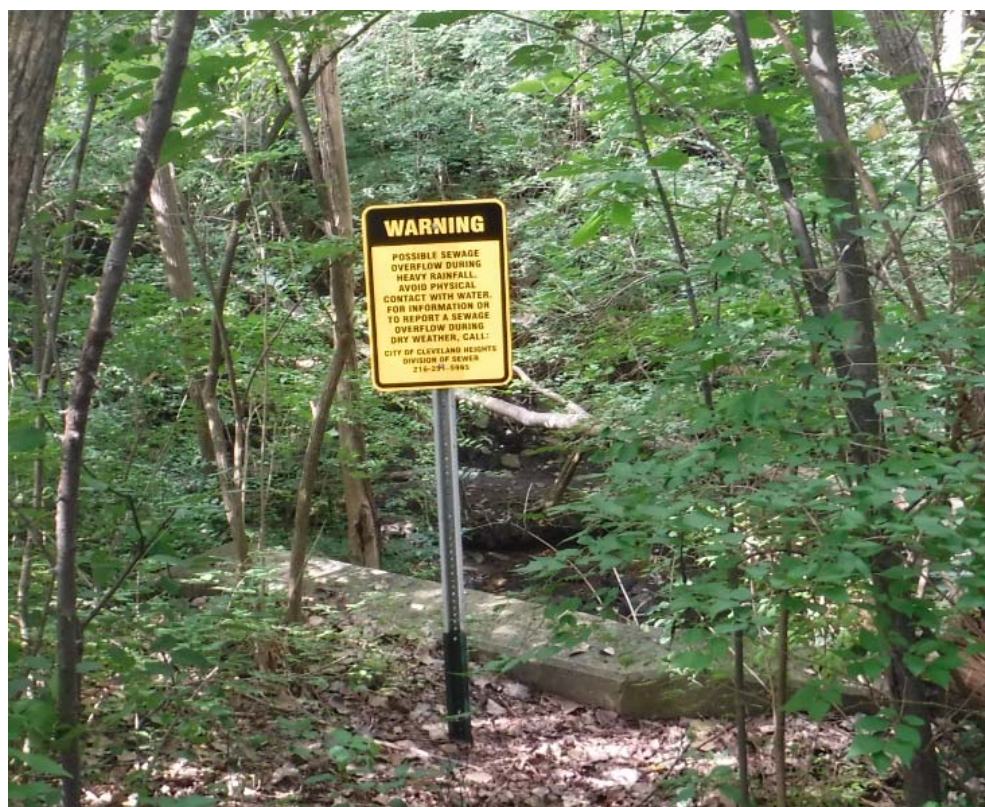
**Figure 1. Example Signage Warning of Potential Wet Weather Overflow**

- Cleveland Heights adopted the Cuyahoga County CCTV Sewer Inspection Standard Operating Procedure with a supplemental guidelines memorandum as its standard for in house CCTV operations.
- Cleveland Heights developed a Manhole Inspection Guidance Document for in house manhole inspections.
- Cleveland Heights erected signage to inform the public that a rain-related sewer overflow may occur at locations in which a waterway could be accessed by the public. An example of the signage posted can be seen in **Figure 1**.

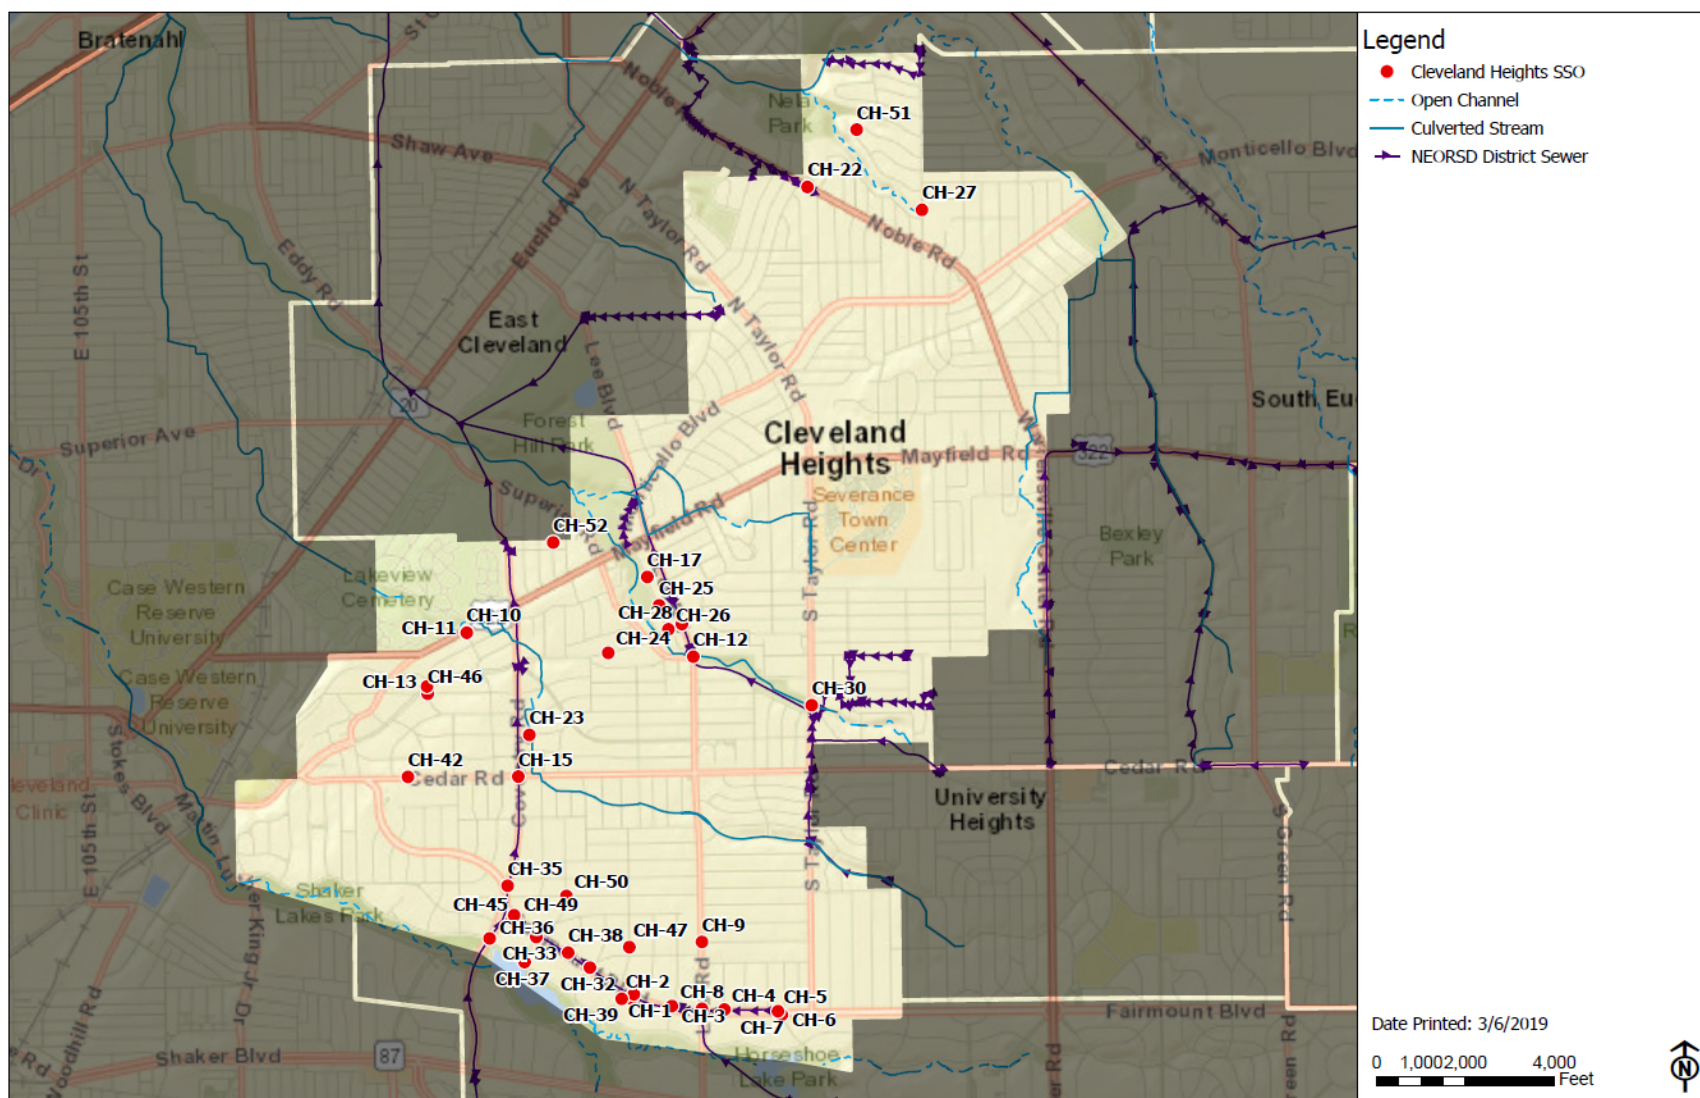
**Figure 2. Known SSO Structures Status – 2018**

**Figure 2** shows the known SSO structure locations in Cleveland Heights as of the end of 2018.

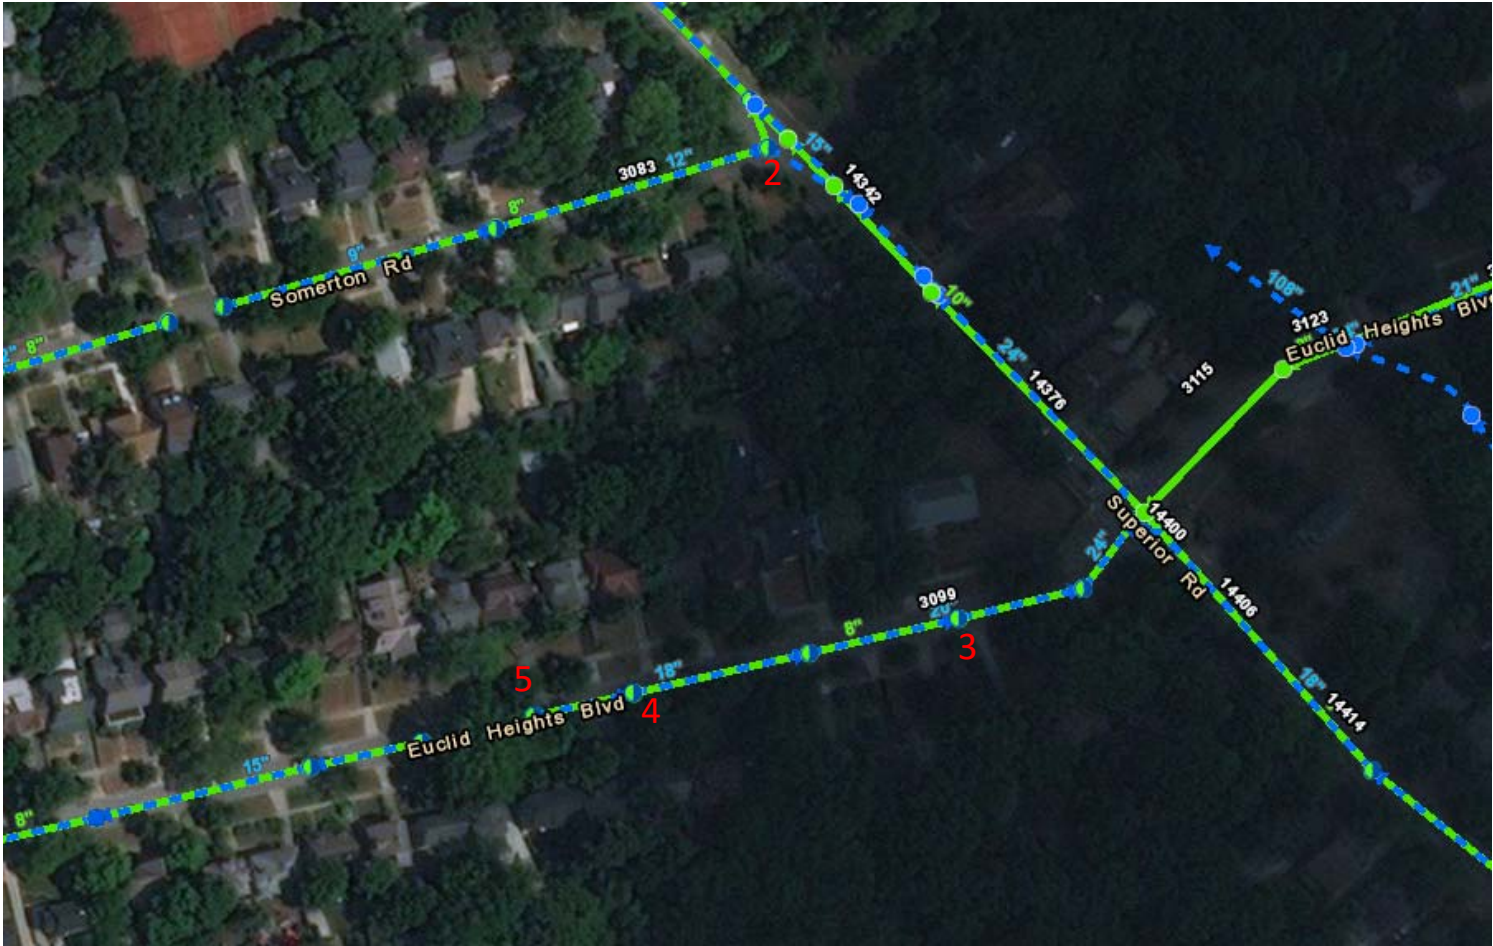
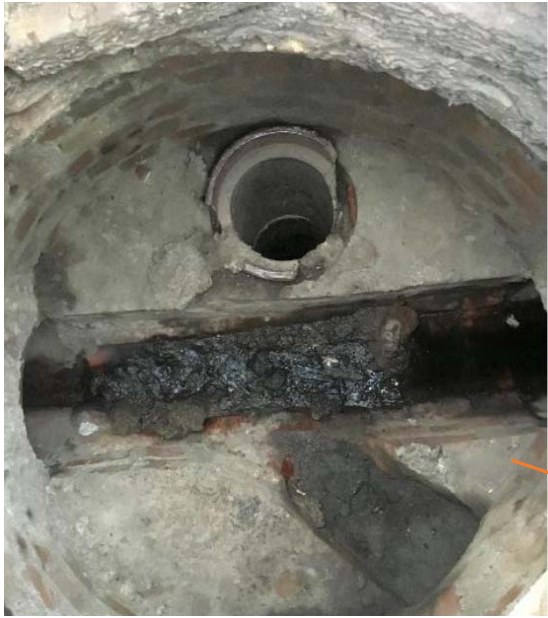
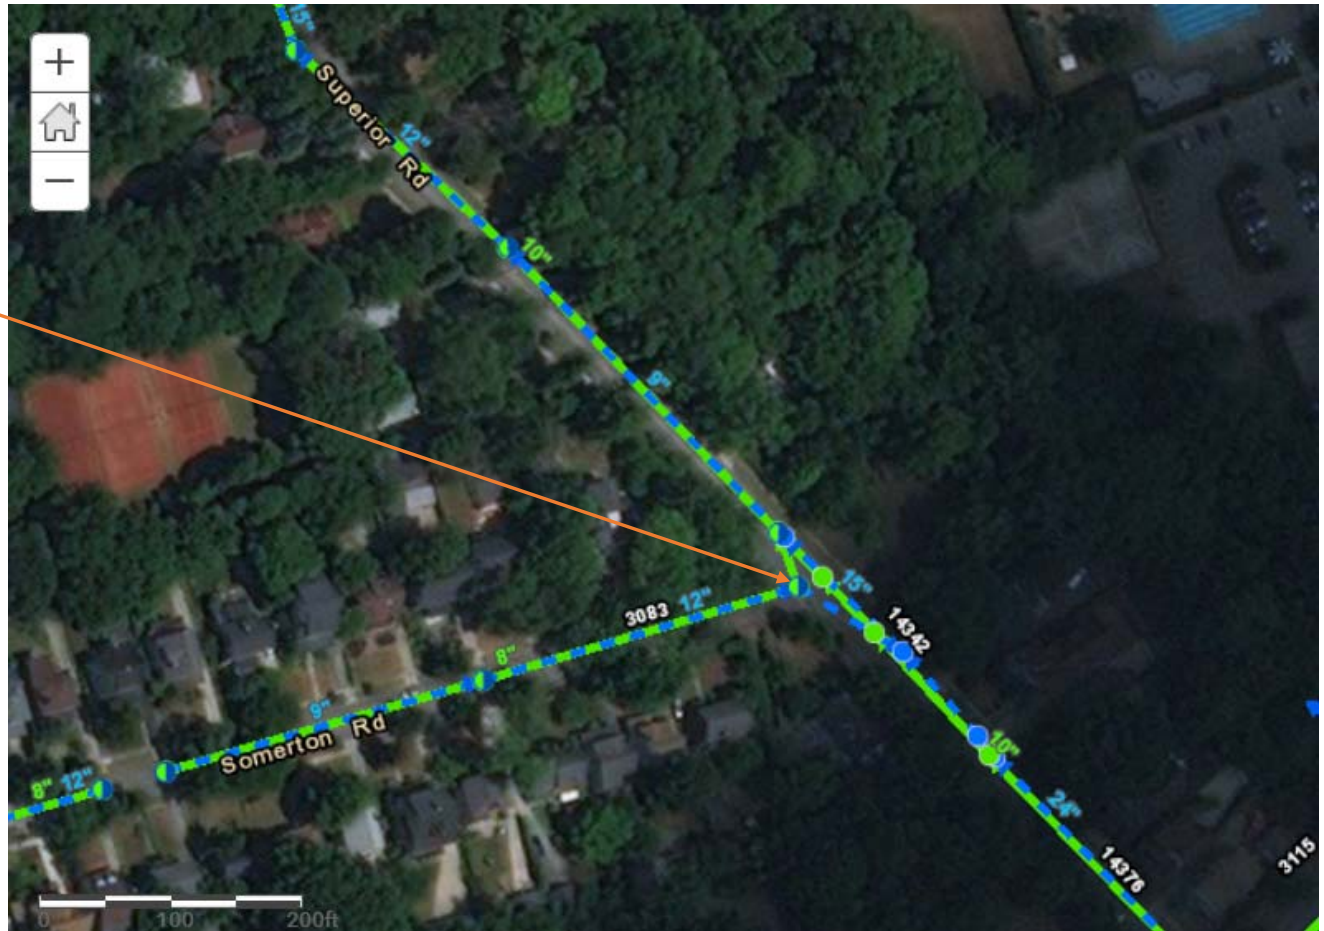
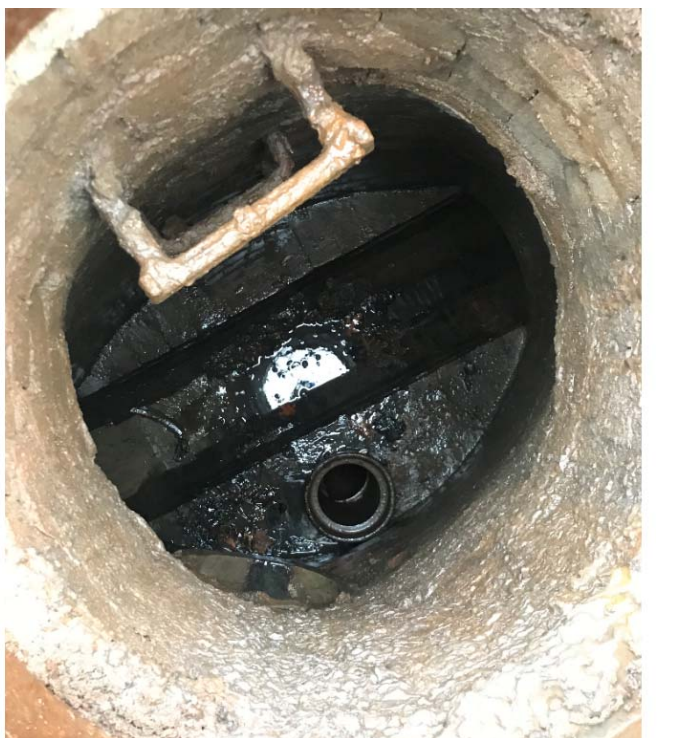
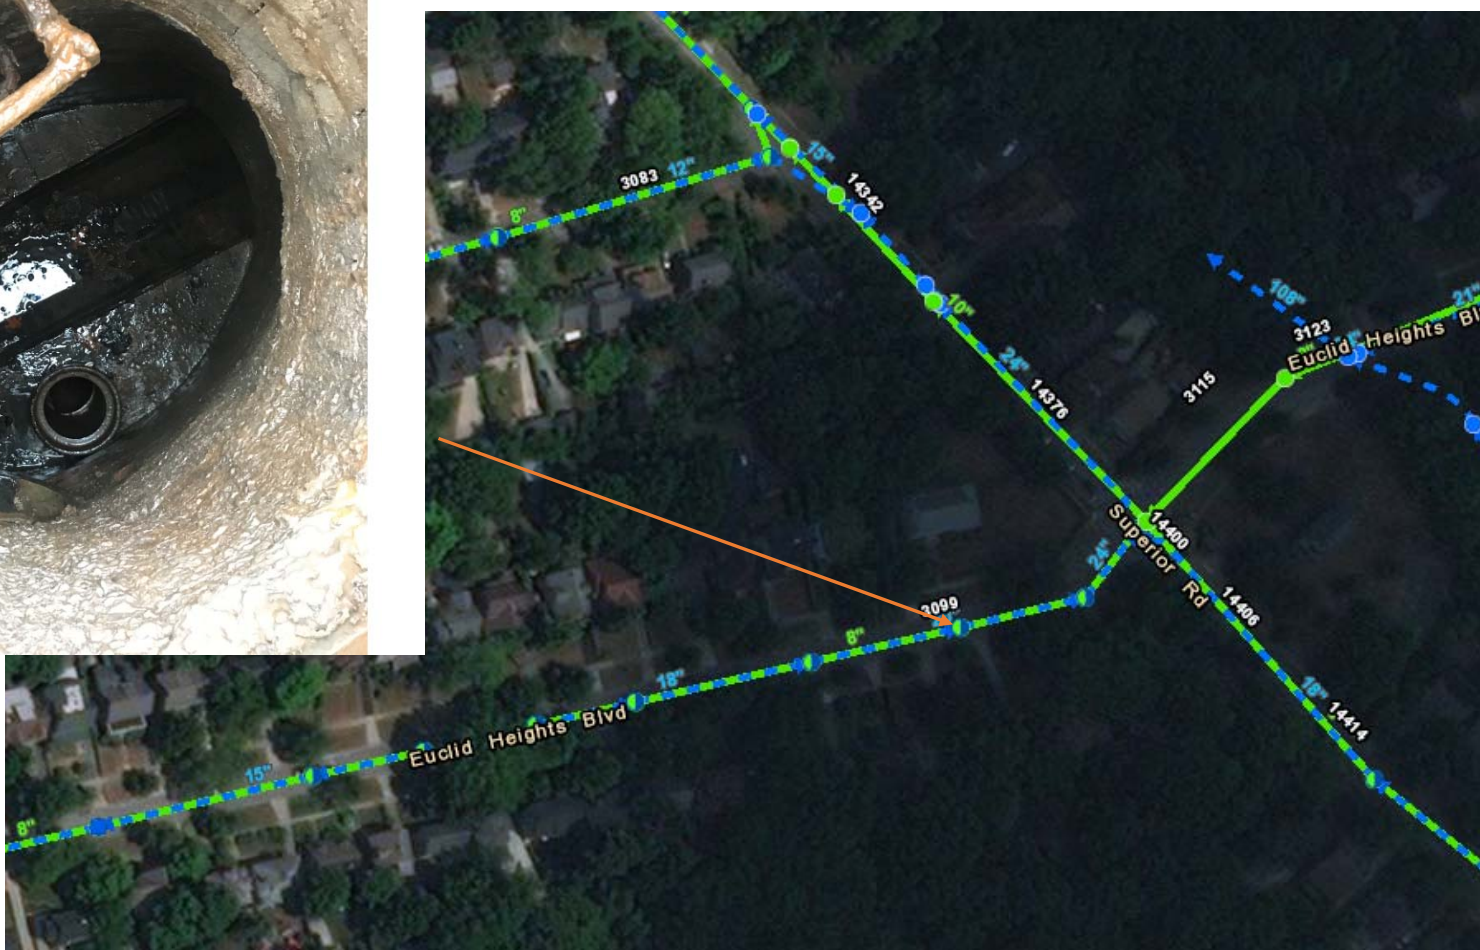
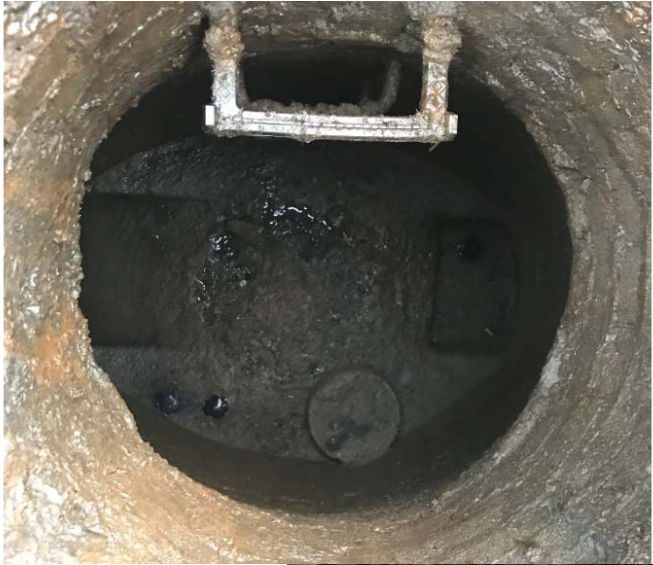
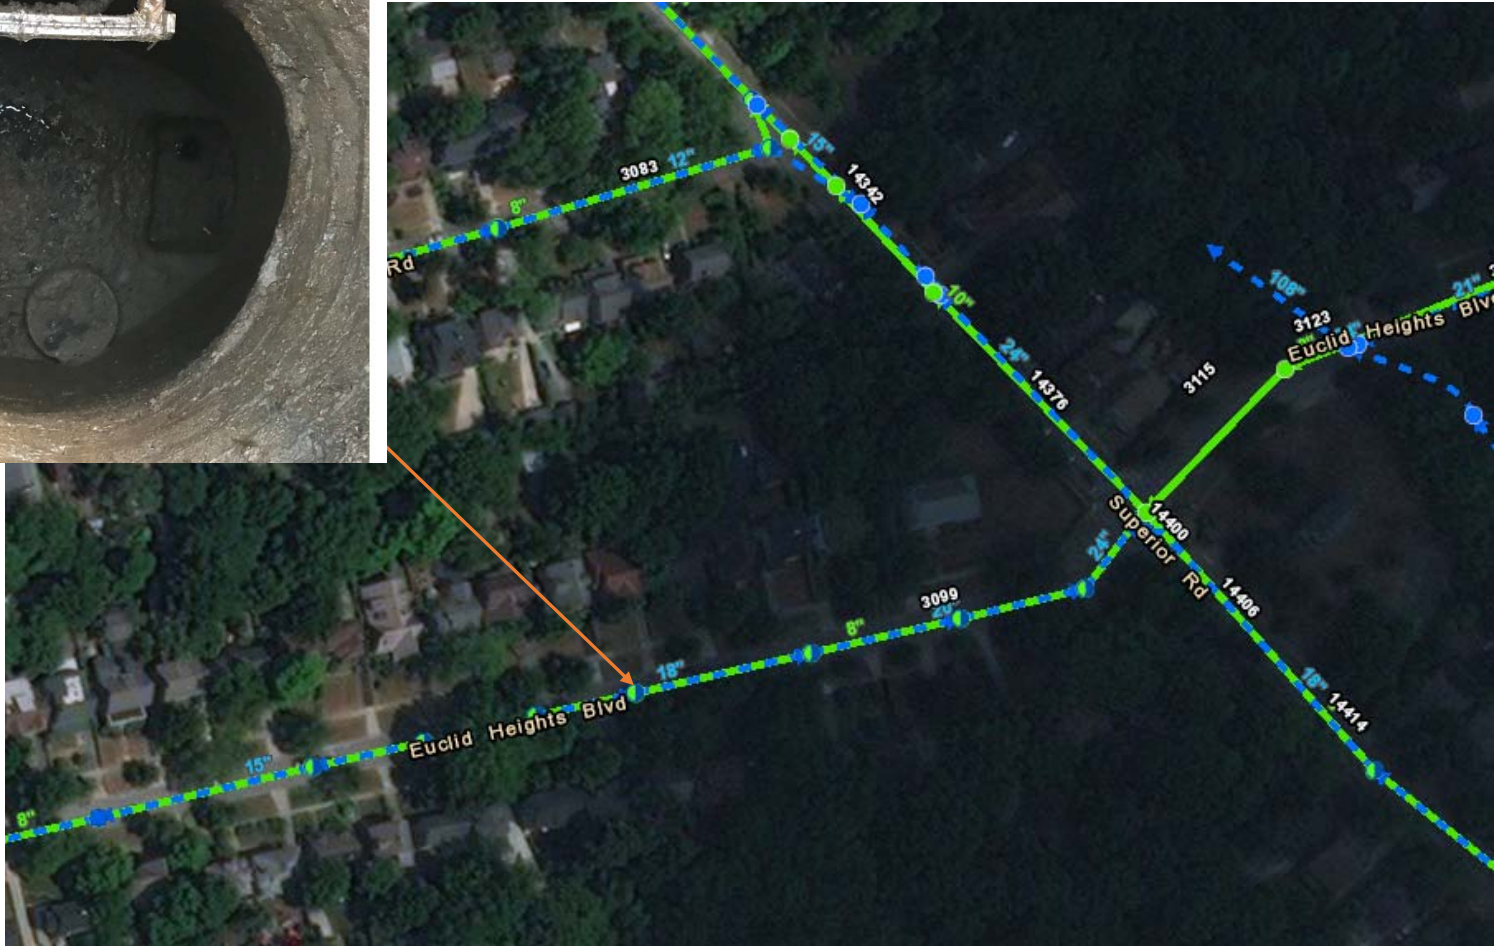
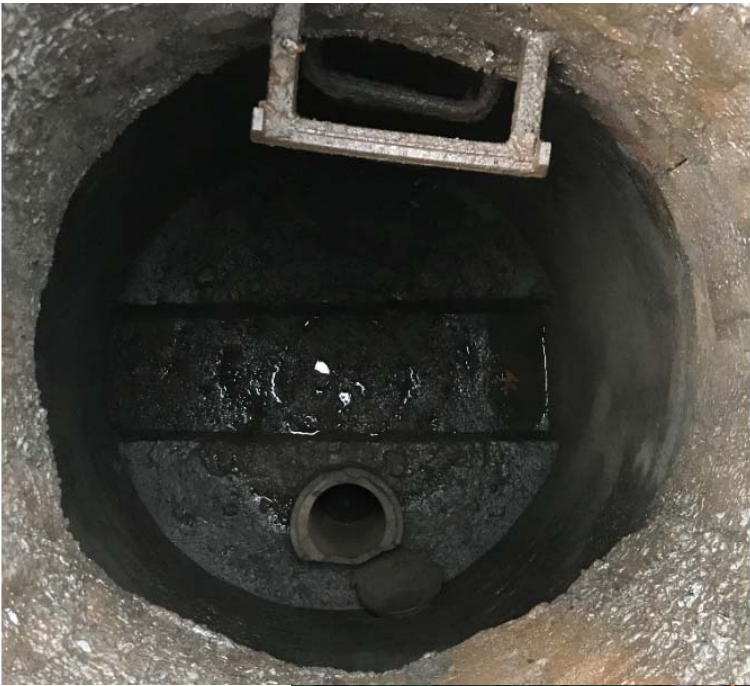
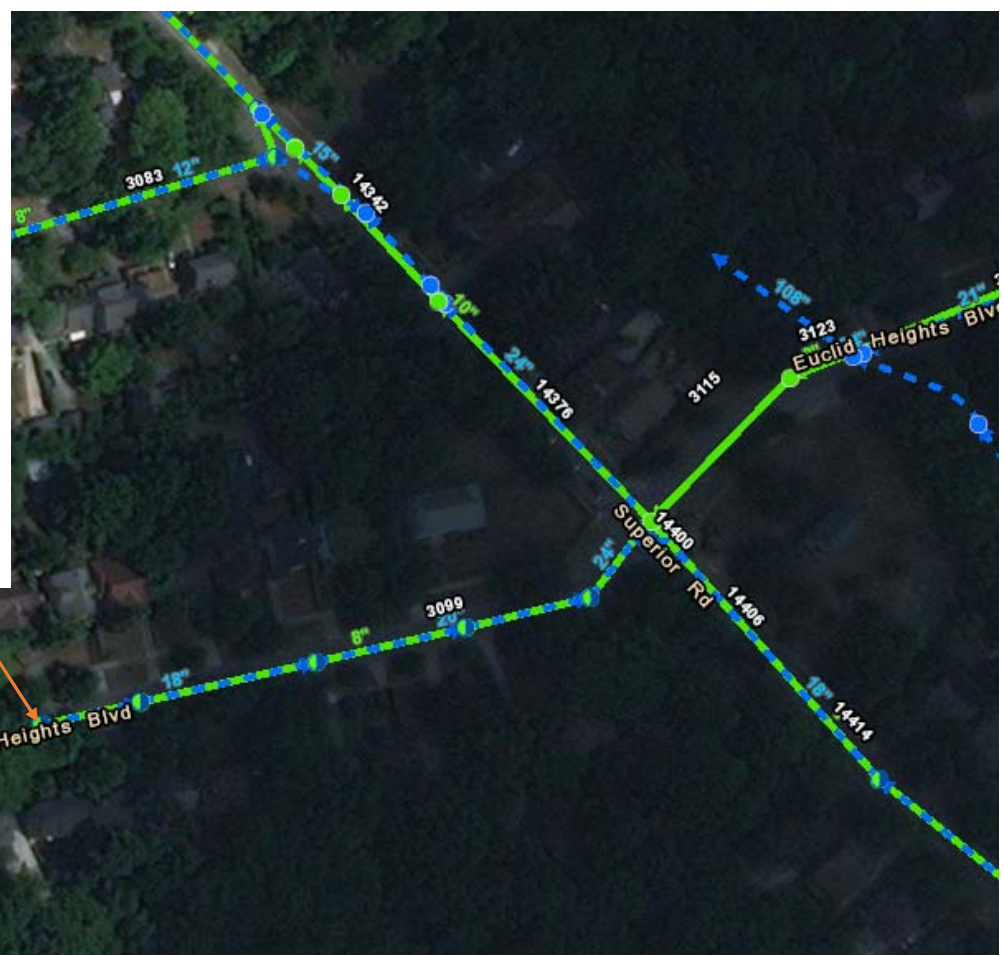
## **Appendix A – Sanitary/Storm Cleanout Connections**

- Identify potential project(s) for submittal under NEORSD Member Community Infrastructure Program (MCIP).
- Continue CMOM implementation activities.
- In 2018, 5 common trench manholes were found to have 6-inch cleanout pipes configured vertically from the sanitary sewer below to the storm sewer manhole above, allowing for potential interaction between the systems. Cleveland Heights capped the cleanout pipes that were not already capped with tethered discs. The discs will be monitored to determine if flow interaction is occurring. Tracking will be performed similar to the tethered block SSO monitoring at other locations to ensure that it is safe to proceed with permanent capping. Information on these locations and photos of the manhole configurations are provided in **Appendix A** of this report.
