# FOREST HILL PARK

## Updated Master Plan 1999

East Cleveland and Cleveland Heights, Ohio

Pressley Associates, Inc., *Landscape Architects* ■ Cambridge, Massachusetts

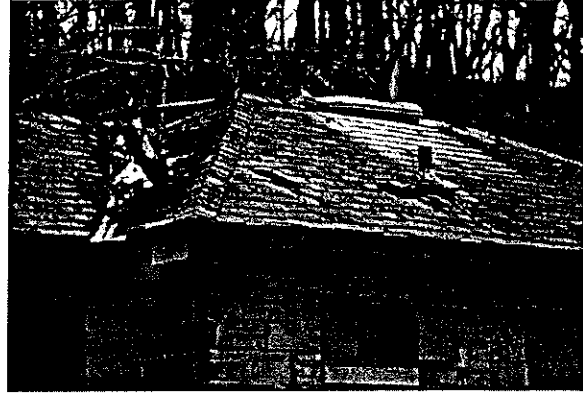
This structure is not in use because of problems with piping and maintenance of the plumbing. With a small amount of modification the toilet rooms have sufficient space to make them accessible to persons with disabilities.

The roof has been badly damaged, 1998.

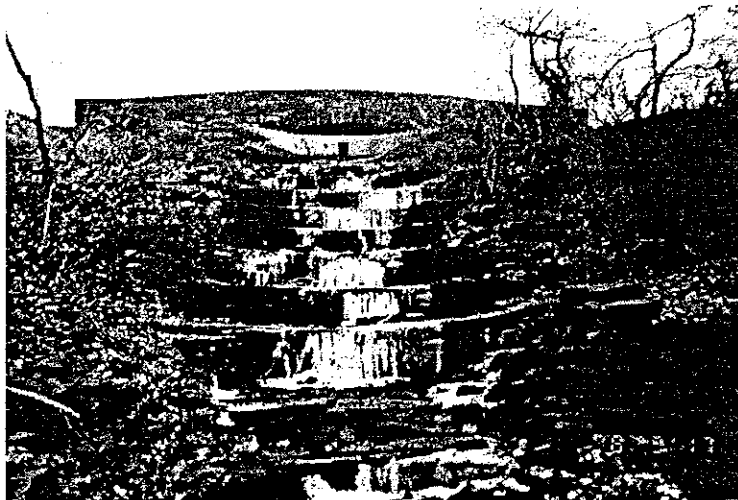
Stone stepped spillway at Lake, 1998.

- The trash racks just upstream of the inlet to the 14' x 8' box culvert should be cleaned of all debris and sediment and then inspected for structural damage. If any structural damage is found, repairs should then be made, as needed, to restore their integrity. Further study and utilization of best engineering practices should be employed.
